## WICHTIGER HINWEIS FÜR ALLE KUNDEN UND AUSSENDIENSTMITARBEITER DER FA. ETISYS UND ALLE BENUTZER DER BarTender SOFTWARE und WIN-XP

# Windows Security Patch Issued February 13, 2007 by Microsoft Can Cause Text Truncation with BarTender v7.10, 7.50 and v7.51

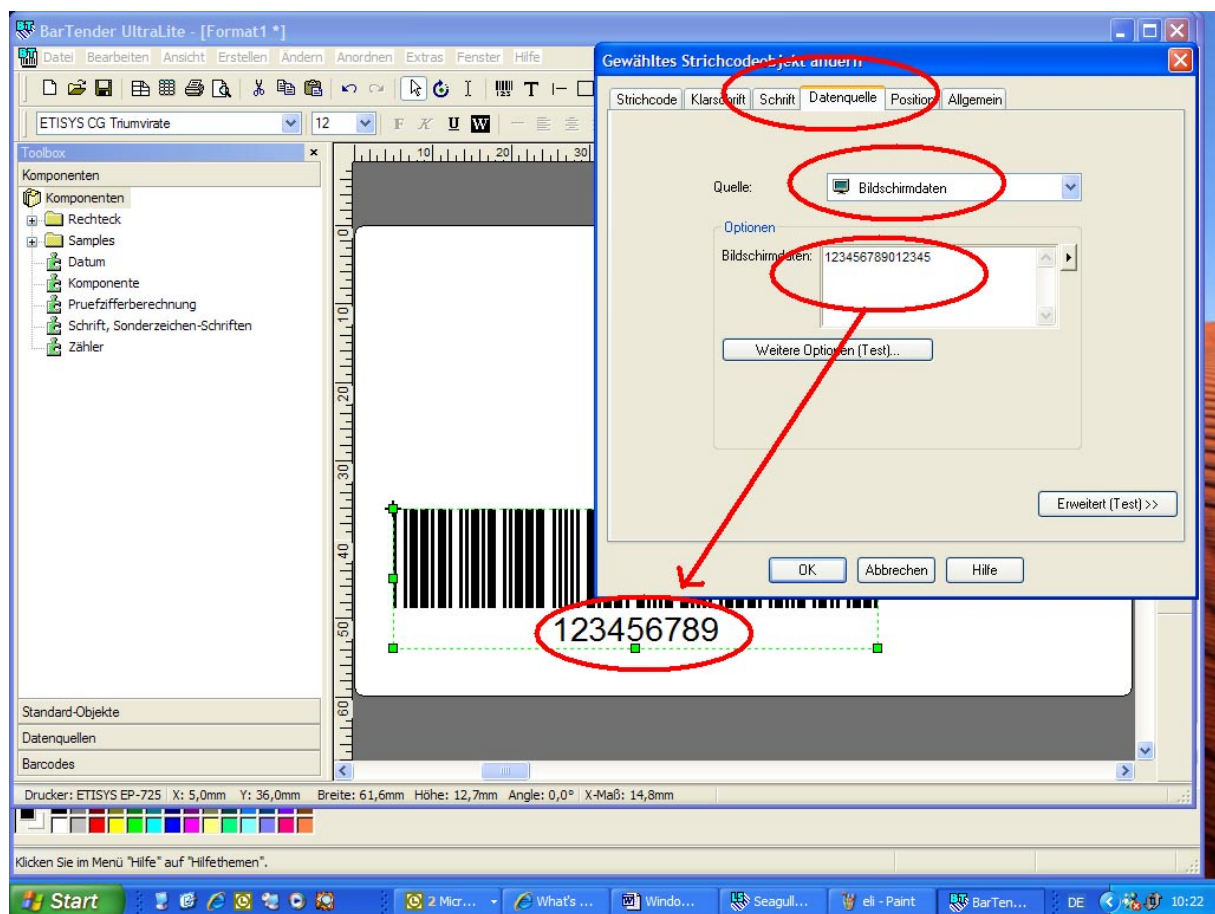
Die Firma Microsoft hat mit dem Datum vom 13. Februar 2007 ein neues Sicherheits-Patch veröffentlicht, welches gravierenden Einfluss auf alle Eingabefelder (Text und Barcodes) nimmt, die über die Dialogbox **Gewähltes Textobjekt Ändern – Datenquelle – Bildschirmdaten** eingegeben werden.

Für alle BarTender Versionen kleiner als 7.70 – also 7.51, 7.50 und 7.10 werden alle Eingaben die länger als 9 Zeichen sind, direkt nach dem 9. Zeichen abgeschnitten.

Dieser "Fehler" beruht auf der Tatsache, dass die Datei **RICHE20.DLL (Bestandteil von WIN XP seit der Veröffentlichung der ersten Version)**, die von vielen Windows-Programmen für die Eingabe von Texten verwendet wird, von Microsoft verändert wurde.
