## WICHTIGER HINWEIS FÜR ALLE KUNDEN UND AUSSENDIENSTMITARBEITER DER FA. ETISYS UND ALLE BENUTZER DER BarTender SOFTWARE und WIN-XP

# Windows Security Patch Issued February 13, 2007 by Microsoft Can Cause Text Truncation with BarTender v7.10, 7.50 and v7.51

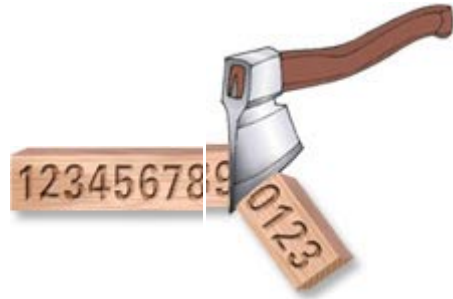
Microsoft released a Windows Security Patch on February 13, 2007 that actually changes the way a Windows-provided text component works. As a result, two very-well tested and long-used past versions of BarTender will now "cut off" keyboard-entered data in certain situations. The problem and four available workarounds are discussed below.
